Enhanced Preliminary Assessment Report:

Holmdel Army Housing Units
Holmdel Township, New Jersey

November 1989

Environmental Research Division
Argonne National Laboratory
Argonne, Illinois 60439

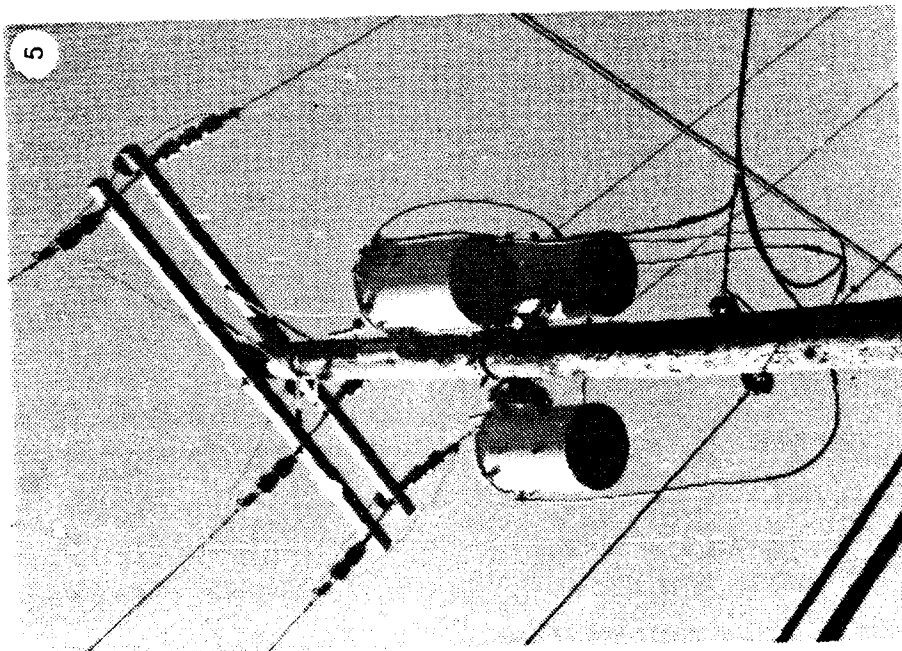
The electrical service to the Holmdel housing area is provided by a local public utility, but all on-site transformers are the responsibility of the U.S. Army. No record of any inspection of these transformers for leakage or of any testing of their contents for the presence of PCBs was found. However, no evidence of spills or leaks was observed during the site visit.

5. Close-up view of three electrical transformers; on-site transformers are owned by the U.S. government.
6. Furnace room in unit #204; no insulation materials on the pipes.

It is recommended that electrical transformers on-site be inspected for possible leakage. It is also recommended that all existing transformers, as well as the soil at the base of the poles, be tested for the presence of PCBs and that the contents of the transformers be labeled. Any PCB contamination found should be remediated as required.

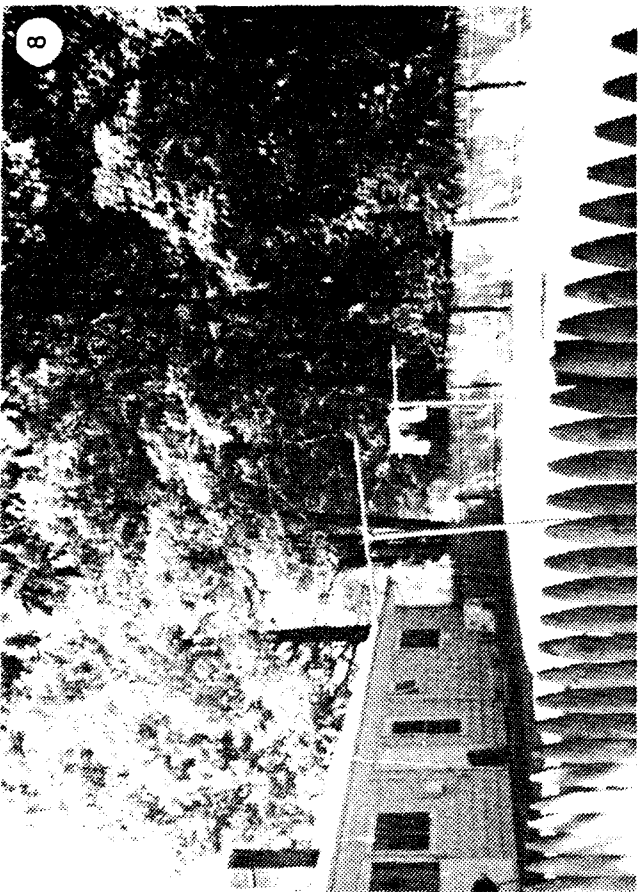
7

7. Looking northwest at the rear units #201 to 206; the ground slopes steeply in the wooded area at the left edge of the view.
8. The rear of a housing unit; steep sloping ground starts beyond the fence on the far side of the view.
